St. George's Church Site Visit Report

On March 15, 2019, I inspected St. George's Church in order to identify and prioritize structural deficiencies so that upcoming rehabilitation work can be applied in the most beneficial manner. The next phase of this investigation is to perform a structural analysis to evaluate the most serious deficiencies and suggest stabilization/reinforcement schemes. However, during my site visit it became readily apparent that the most pressing need is a new roof for the building. The next engineering phase will be delayed so that all future funding can be applied toward providing a new roof. Therefore this is a preliminary report to document significant findings.

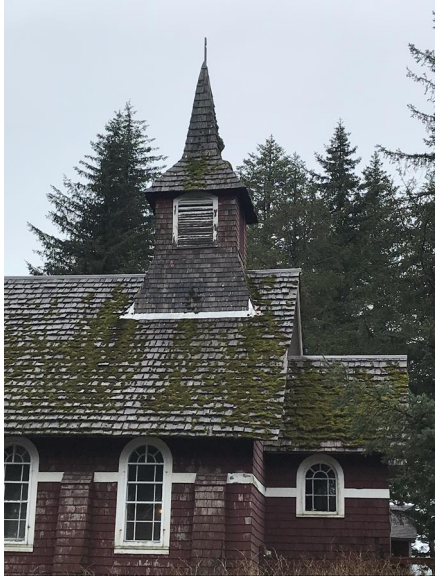
Photo 1 - Roof

The roofing is wood shake shingles over building paper over board sheathing. The roof is at the end of its useful life and needs to be replaced. There is excessive moss growth and areas with missing or deteriorated shingles, reference Photo 1. The building is in dire need of a new roof and this should be the top priority for future maintenance. The only active roof leaks detected were at the top of the steeple. Wood framing was damp where the bell tower meets the main roof but did not appear to be actively leaking at the time of my site visit. Numerous other spots were observed that have leaked in the past and will leak in the future with prolonged exposure to rain and snow on the roof.

The building is in overall good condition considering its age and location. However the roof is in poor condition and is starting to leak and desperately needs to be replaced. Roof replacement should be the number one priority in order to protect this historic structure. Roof replacement will most likely require a total or partial re-build of the steeple framing and cross. Other items that should be addressed in the short term include:

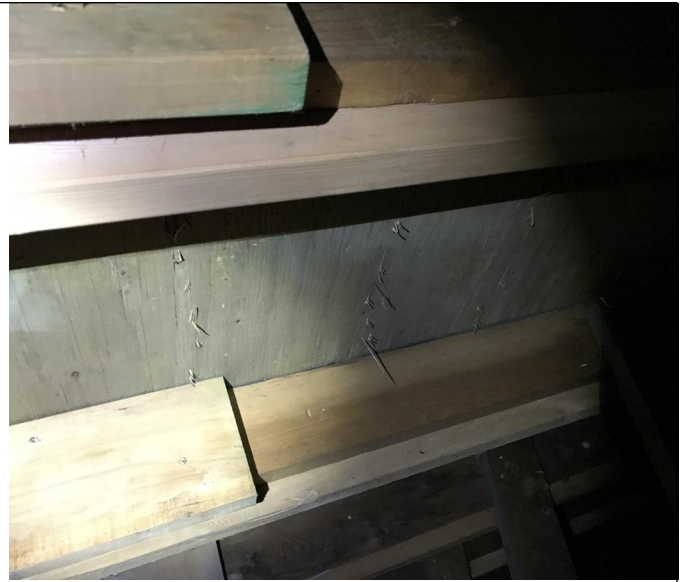
Photo 2 – Roof Rafter Reinforcement

The roof structure is built with "scissor trusses" spaced at 24"oc, reference Figure 1. The top chord (roof rafters) are 1 ½ x 5 ½ at a 12/12 pitch. Many of the rafters have been reinforced with various size wood joists, reference Photo 2. The bottom chord (ceiling joists) are a 1 ¾ x 5 ¾ plus a 1 ¾ x 3 ¾ member at a 7/12 pitch. Across the top of ceiling at a height of 16.4'

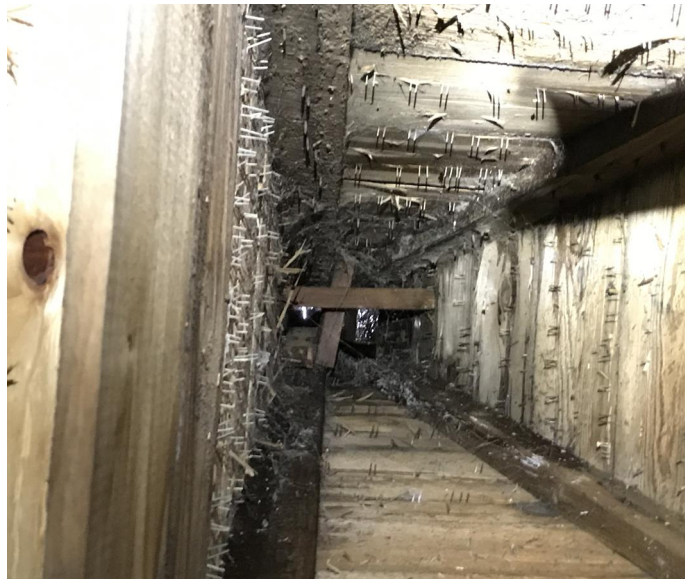
Photo 3 – Steeple Framing

The top of the steeple has been leaking for some time and the wood appeared very rotten and in need of replacement, reference Photo 3. The top of steeple was too high to allow testing of the wood members but an inspection with a flashlight indicated wet and rotted wood. The steeple framing should be replaced at the time the building is re-roofed.

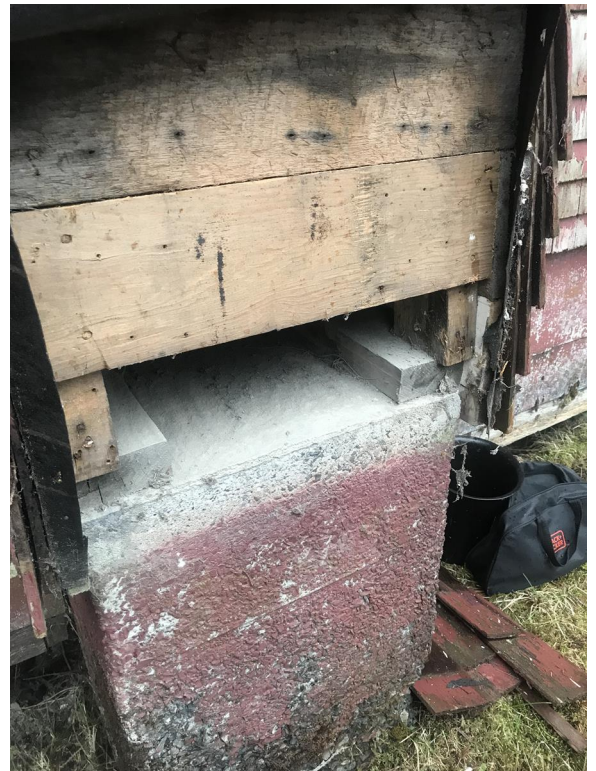
Photo 4 – Exterior Pilaster Wood Framing

One of the exterior wall “pilasters” was partially dismantled so it could be inspected for the possibility of using it for added reinforcement to restrain walls from leaning outwards. We choose the wettest pilaster for inspection to give a worst as scenario observation. All wood sheathing and framing under the shake shingle siding was dry and in good condition, reference Photo 4.

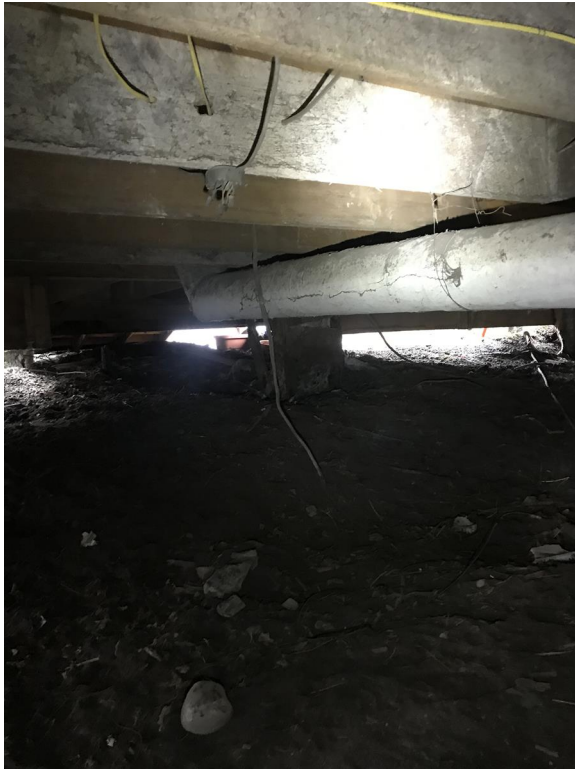
Photo 5 – Floor Framing

Floor framing was inspected from the underside crawl space and appeared to be in good condition, reference Photo 5. Calculations indicate an allowable floor live loading of approximately 25 pounds per square foot (psf). By modern building codes the occupancy would be considered assembly with fixed seating and would have a minimum design live load of 60 psf. This deficiency is not unusual for a structure of this vintage but is an indication that the church should not be used to accommodate large gatherings. 25 psf distributed over the seating area of the church equates to approximately 80 people.

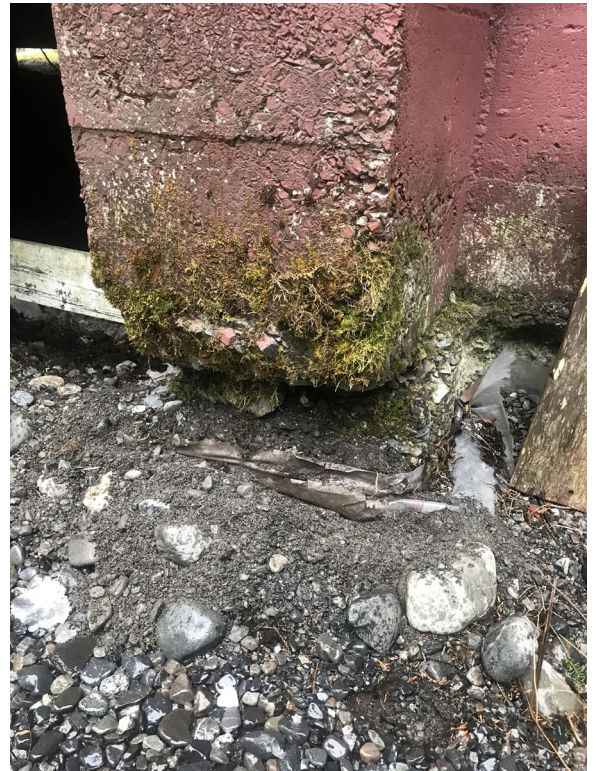
Photo 6 – Concrete Pier at Grade

Foundations under north half of the building are concrete piers presumably founded on concrete spread footings. The south half of the building is concrete basement walls and a concrete basement slab on grade. The portions of the foundation that were visible were in fair condition. There is considerable degradation and loss of concrete where the piers meet grade, reference Photo 6. This situation needs to be addressed in order to restore the structural integrity and esthetic appearance of the piers.

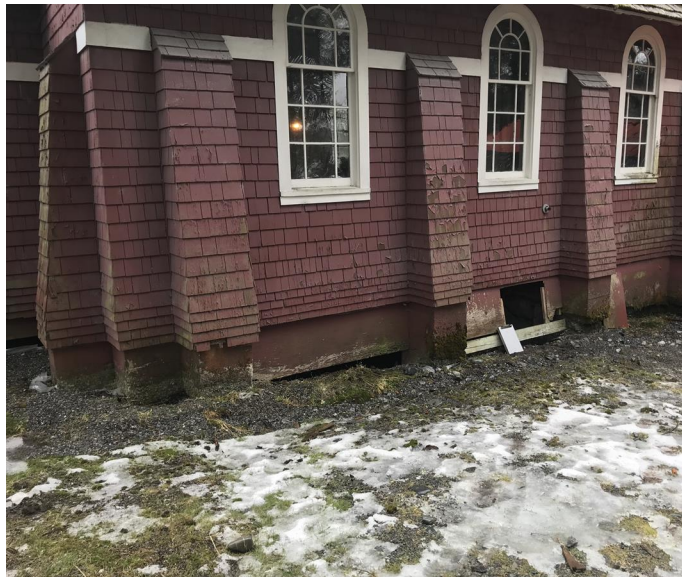
Photo 7 – Crawl Space Skirting

The wood skirting between piers is in poor condition and needs to be replaced. Reference Photo 7.

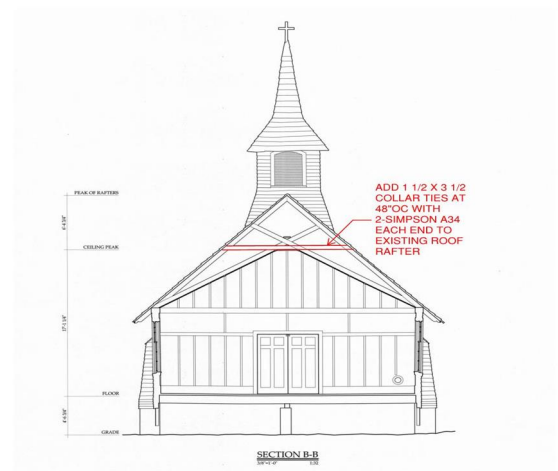
Figure 1 – Building Section

The wall studs were covered with finishes and could not be inspected. The top of east and west walls are leaning out by up to 4”. This is most likely caused by the roof trusses pushing the wall outward as the truss loads up with snow and deflects. The walls do not lean out at locations where a perpendicular wall restrains it. I did a site visit on August 7, 2014 (to inspect the neighboring Red Dragon building) and measured the church wall deflection then. The deflection has not increased in the last $4\frac{1}{2}$ years so this situation does not seem to be getting worse. This situation should be addressed and the next phase of the BBFM scope of work is to do a roof truss structural analysis and wall analysis to address and fix this condition, but at this point it is, in my opinion, for important to install a new roof on the building. This is not to say that a heavy snow year could not cause further deflections or other problems (up to and including roof collapse), but all things considered I recommend spending available funds on a new roof rather than engineering analysis of the roof trusses and walls which have been standing for 100 years.

One simple and inexpensive measure that should be taken to mitigate further wall and truss deflections is to add additional collar ties as shown in Figure 1. Currently every other truss has a collar tie and adding collar ties to the remaining trusses will strengthen and stiffen the trusses and reduce further wall deflections.

1. Repair steeple louver slats.
2. Re- attach sheet metal over east steeple louver opening.
3. Add collar ties at 48" on center to roof trusses as indicated in Figure 1.
